Allied Paper, Inc./Portage Creek/Kalamazoo River Superfund Site
Multi-Area Health and Safety Plan Addendum 7: Potential Contact with Harmful Algal
Blooms

**Addendum 7, Potential Contact
with Harmful Algal Blooms**

Allied Paper, Inc./Portage Creek/
Kalamazoo River Superfund Site

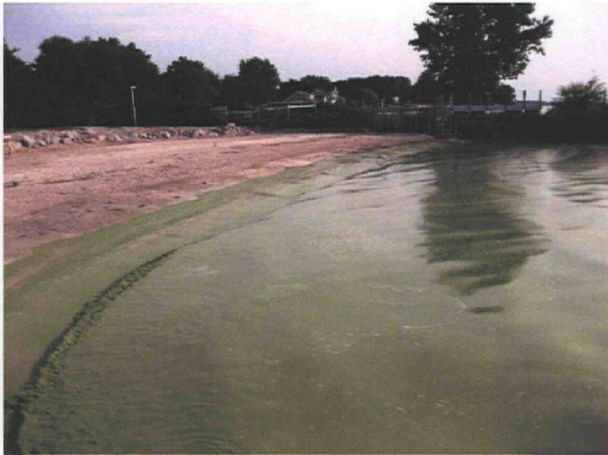
*A HAB on the shore of Catawaba Island, OH.
Photo by NOAA 2009.*

HABs consist of various single-celled organisms living in water including algae and dinoflagellates. HABs are technically cyanobacteria that are capable of photosynthesizing. When certain environmental conditions are present, such as (1) shallow, warm, calm water; (2) excess nutrients; (3) low-water or low-flow conditions; and (4) high sunlight levels, these organisms can rapidly multiply. The resulting dense population of algae is buoyant and tends to float to the surface, where it forms scum layers or floating mats. Due to wind conditions, they tend to accumulate in the shallow portions of bodies of water (Michigan Department of Natural Resources and Environment [MDNRE] 2010). The blooms may appear blue, bright green, brown, or red and may look like paint floating on the water. Some blooms, however, may not result in the change of the appearance of the water.

surface. HABs also appear smaller than *Cladophora*, which can grow up to three feet long and appear filamentous and branched. HABs, however, form visible colonies.

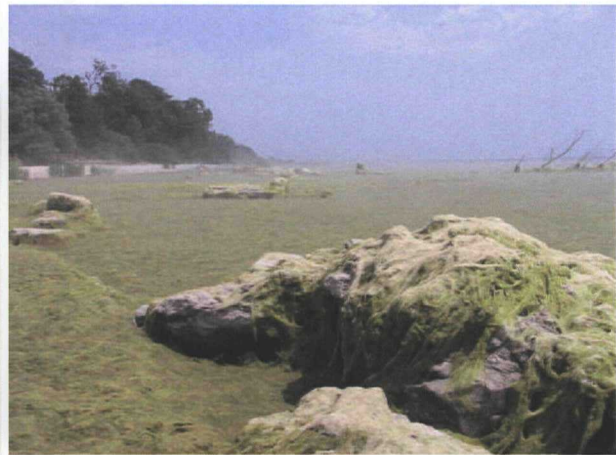
*A Cladophora bloom on the shore of Lake Erie.
Photo by Scott Higgins 2006.*

HABs, which are often referred to as “blue-green algae blooms,” can be confused with Cladophora, a green algae, because both can create wide-spread blooms. However, not all blooms or surface scums are harmful. True algae like Cladophora do not generate the toxins associated with HABs. Blooms of Cladophora produce “muck” zones on beaches and lake shores and may potentially harbor bacteria, but they do not produce harmful algal toxins. In contrast, the cyanobacteria that cause HABs are capable of producing a variety of toxins, and it is the exposure to the toxins that poses potential health risks. True algal blooms and HABs also look and behave differently – HABs tend to stay in water column while Cladophora wash up on shore in mats. When HABs die, they sink to the bottom while Cladophora float to the
